## *Interim report*

### **Fatal accident on board *m/v Morraborg* – PEBG - in port of Holmsund, Sweden, July 3<sup>rd</sup> 2011, during mooring operations**

**S-95/11**

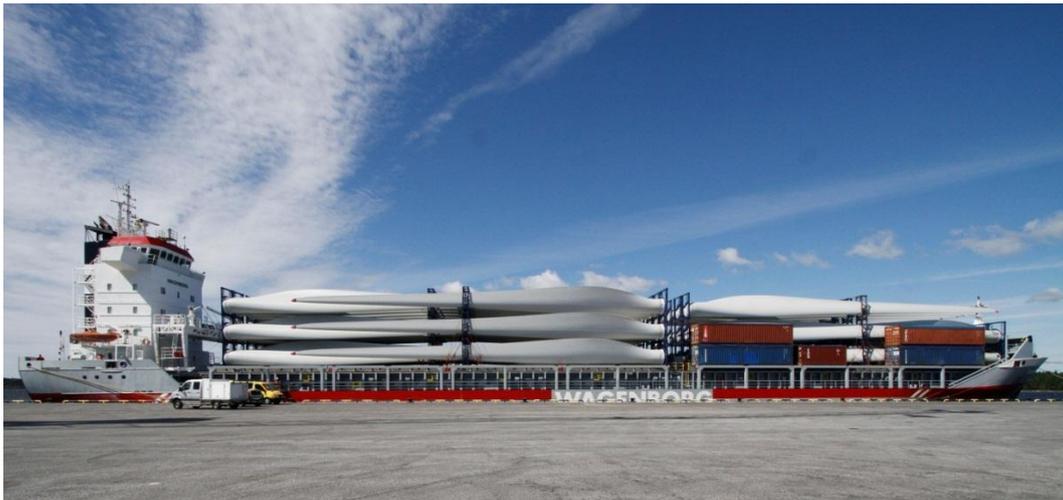
*Fig. 1, The Morraborg berthed at Holmsund right after the accident. Discharging of the deck cargo has not yet started.*

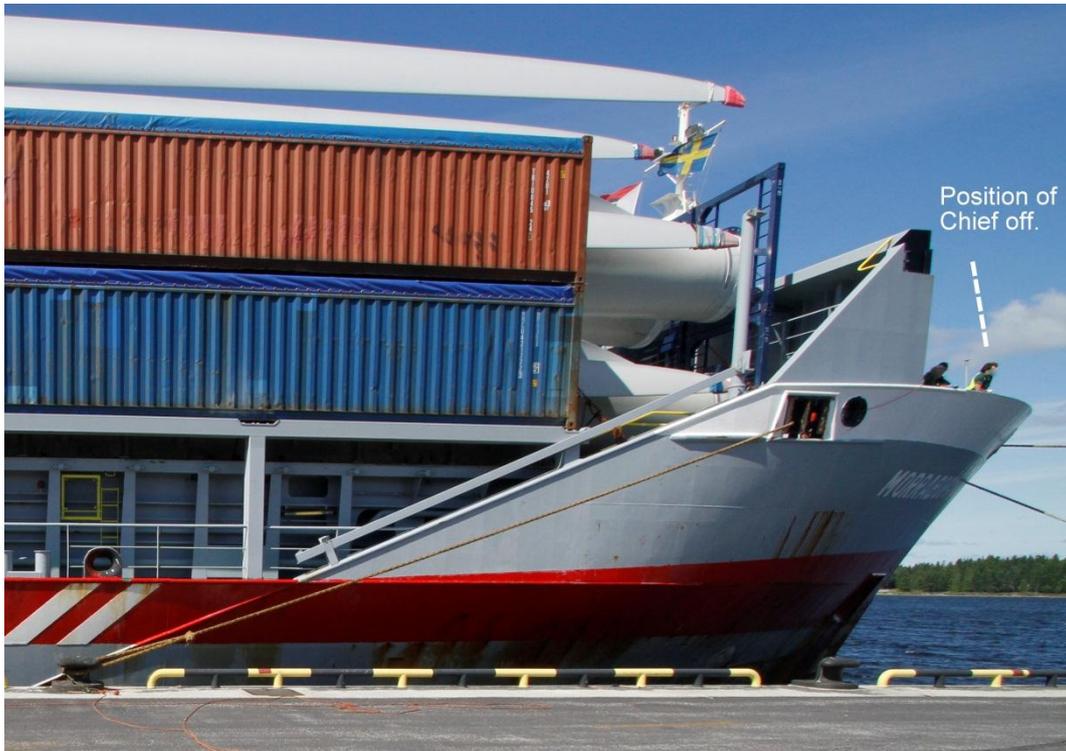
*Fig. 2, Morraborg after berthing in Holmsund. Another person indicates the approximate position of the chief officer at the time of the accident. (Photo from the Police)*

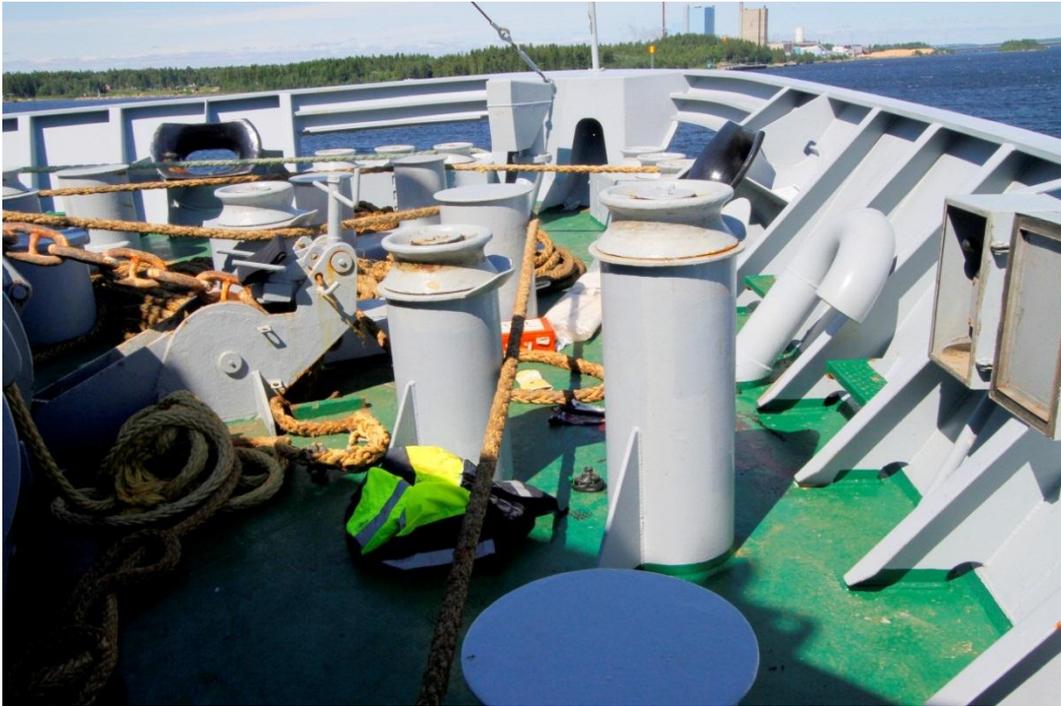
During the manoeuvre the forward spring mooring line broke. The broken rope end flexed back and fatally hit the chief officer to his head and neck.

*Fig. 3, Forecastle deck. To the right; the position of the chief officer when the accident occurred in the area of the platform at the remote control unit. To the left; the remaining of the parted spring line, piled up at its wind lass drum. (Photo from the Police)*

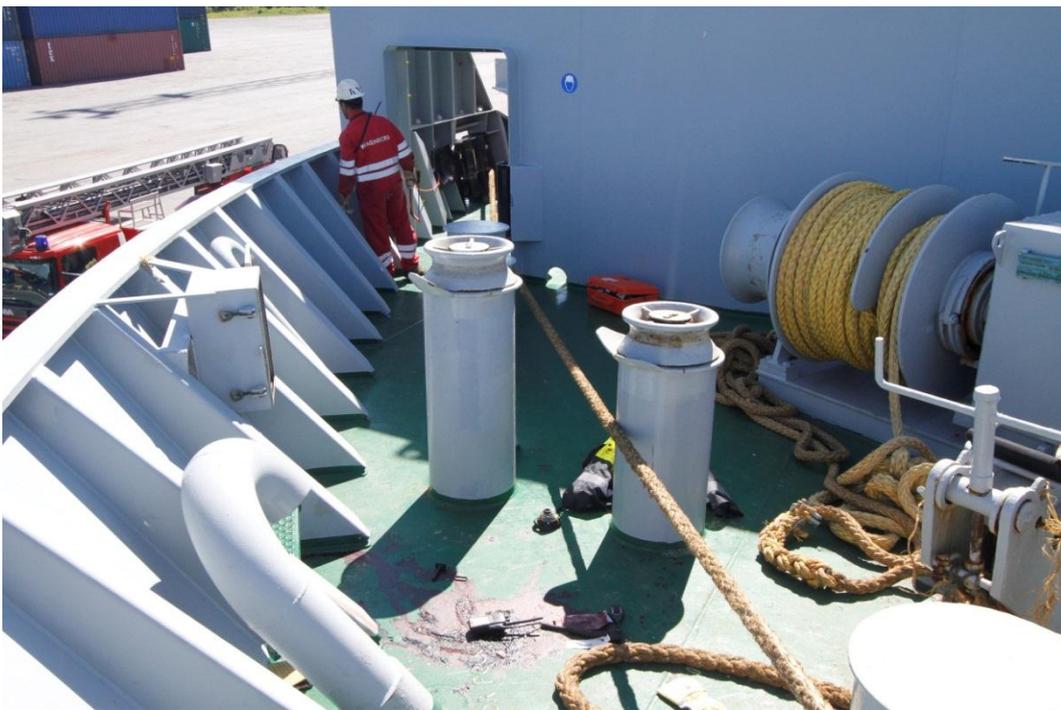
*Fig. 4, Forecastle deck, opposite direction. Through the opening in the bulwark the spring line fairlead can be seen. To the right the wind lass drum with the remaining's of the parted spring line. It has not been established which of the pedestal leads where used. (Photo from the Police)*
