The International Journal of The Nautical Institute

Mariners' Alerting and Reporting Scheme

MARS Report No. 240 October 2012

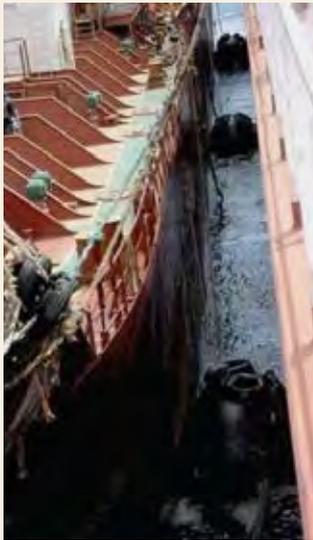
- 1 Substandard conditions: Inadequate equipment. Subsequent expert opinion confirmed that, considering the size of the bunker tanker, the fenders were too small and there were not enough of them, especially for STS operations in open anchorages;

Large bunker vessel on left rigged with three undersized fenders

- 1 Procedures in the SMS revised to:
 - i. Enhance the safety and efficiency of STS and bunkering operations;
 - ii. Improve risk assessment techniques for bunker transfer from bunker barges and bunker tankers at anchorages;
 - iii. Provide guidelines for better mooring planning and execution;
 - iv. Recommend means for more efficient communications between vessels.
- 2 A fleet bulletin was circulated to share the lessons learnt from the incident;
- 3 Incident to be included in officers' pre-boarding familiarisation;

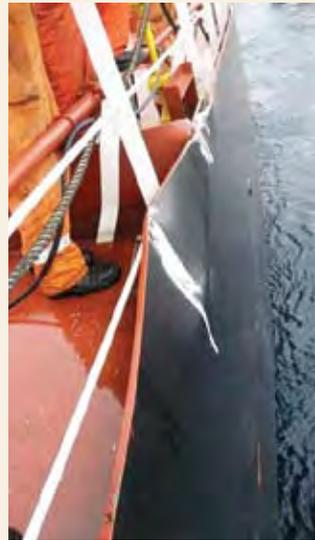
The next morning, following a review of the mooring manoeuvre and evaluation of the prevailing and expected sea conditions, it was decided to proceed with the fuel transfer operation. Unfortunately, due to the bunker vessel's slight residual headway, once again her sternlines tightened and drew her stern in towards the tanker, and both vessels sustained more contact damage in the stern regions. In this incident also, the bunker vessel was cast off and ordered to move away.

View of contact damage near the tanker's stern

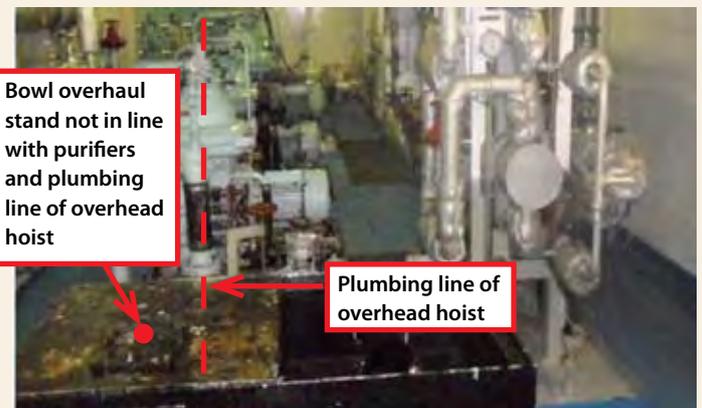
1 The overhead rail of the travelling chain hoist was not vertically above the bowl overhauling stand, requiring the user to pull on the suspended bowl assembly and guide it into the stand manually. This increased the risk of injury to fingers;

Stand for the overhaul of purifiers not in line with the purifiers and plumbing line of hoist. The fourth engineer was pulling on the suspended bowl assembly and attempting to lower it on the overhauling stand (indicated by the red dot) when the accident occurred

- 5 Although the stand had been wrongly positioned ever since the vessel was commissioned, no modification request was raised by ship's staff;
- 6 None of the crew assigned to the task recognised the obvious danger arising from the wrong working practice employed – i.e. positioning a large, heavy object by hand whilst it is being lowered;

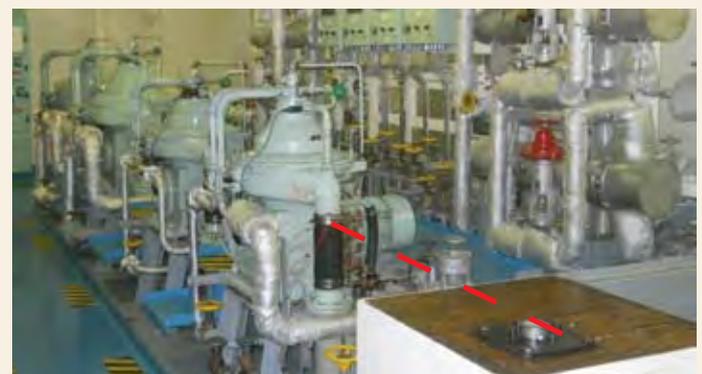
Purifier room on the sister ship – note the correct positioning of the overhauling stand – exactly in line with the row of purifiers and plumbing line of overhead chain hoist

- 7 There appeared to be a training gap on board – no senior engineer or rating had coached the young fourth engineer on safe working practices;
- 8 The same arrangements in the purifier room of a sister vessel were correct in all respects with the hoist plumbing the purifiers and the overhauling stand.

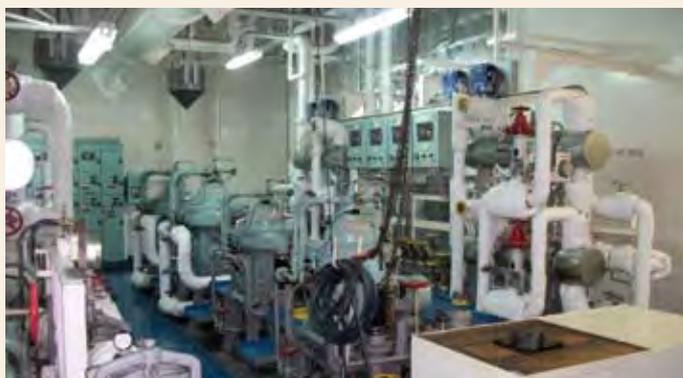
Corrective action #1 implemented – with the purifier overhauling stand positioned correctly

- 1 After the accident, the overhauling stand was properly aligned to be in line with the chain hoist and purifiers;
- 2 Fleet circular issued instructing all vessels to discuss the incident at the next safety meeting;
- 3 Officers ashore will be briefed on this incident by:
 - i. Seminars conducted by the DPA;
 - ii. During pre-joining briefing with the superintendents;
 - iii. New officers joining the company will be briefed in detail during their familiarisation training in the office;
- 4 The knowledge, understanding and proper implementation of safe working practices will be verified during internal audits and other visits on board by the superintendents.

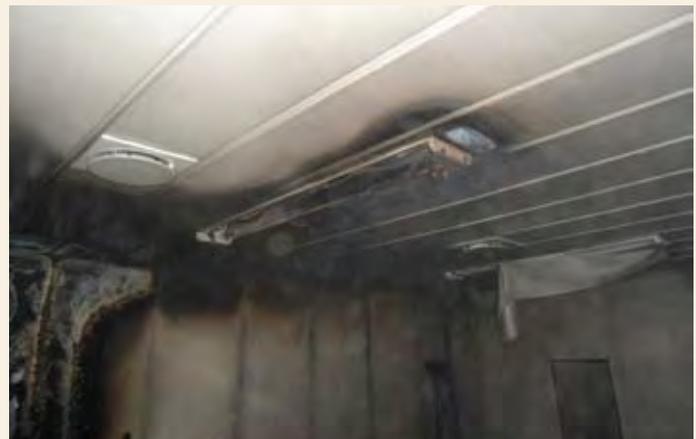
- 1 The crew had not used the gymnasium for three days prior to the incident, but the lights were left on;
- 2 It is suspected that a defective electrolytic capacitor of a panel ceiling light had overheated, and the escaping hot electrolyte and molten plastic sheath fell on and ignited a plastic mat lying on the deck directly below it;
- 3 The Chief Engineer reported that he had already detected poor quality capacitors from the same manufacturer in the past, but he had not reported this matter to the company. A check revealed a further eleven capacitors which showed evidence of overheating and ejection of electrolyte.

View of damaged deckhead panelling and the light fixture that is thought to have started the fire

- 1 All capacitors of the same brand were removed from light fittings on board;
- 2 Crewmembers were reminded that the prompt reporting of even relatively insignificant faults or abnormalities can prevent accidents and generally improve health and safety;
- 3 Lights in unoccupied spaces and compartments not forming part of machinery spaces, accesses and/or working areas should be switched off when not required;
- 4 A safety alert was sent to all vessels with instructions to discuss the incident at the next safety meeting and to implement the above practices.

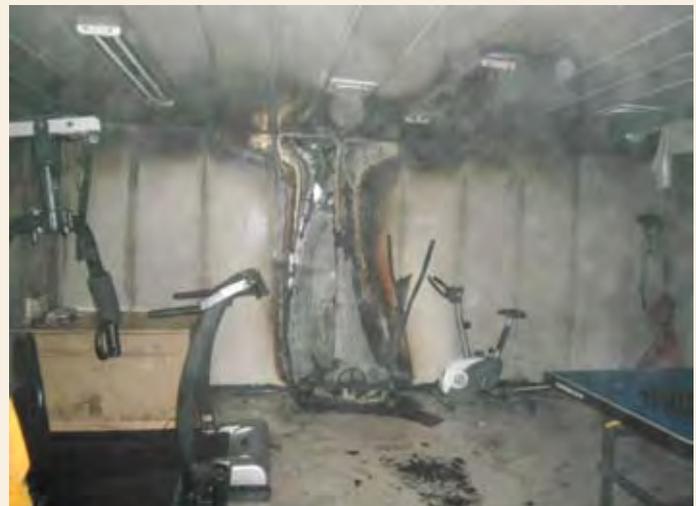
View of fire-damaged bulkhead, deck and deckhead

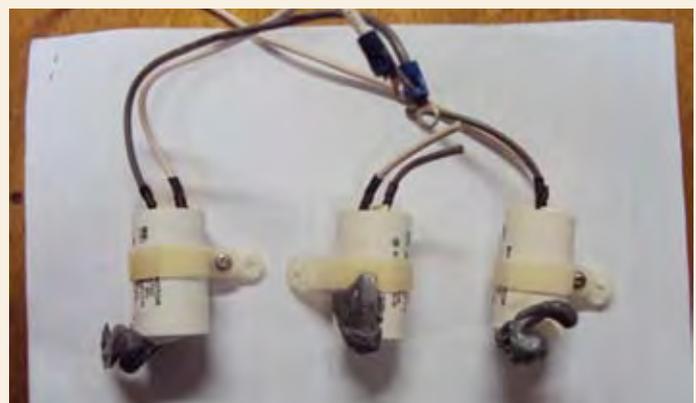
Other capacitors that have overheated with expelled electrolyte
