Seaways

The International Journal of The Nautical Institute

Mariners' Alerting and Reporting Scheme

MARS Report No. 247 May 2013

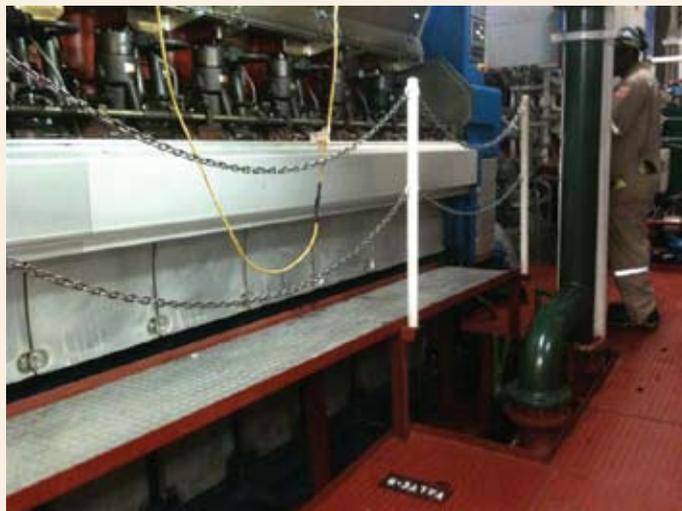
→ The engineering crew was engaged in maintaining the starboard main engine from an adjacent work platform. A Job Safety Analysis (JSA) had been completed for this particular maintenance work. To better access parts and tools required to complete the work, the safety chains and stanchions were removed from the perimeter of the raised work platform, running along the engine side about half a metre above the deck plating. As the work was nearing completion, the Assistant Engineer, while facing the engine, hastily stepped back from the work platform and down to retrieve a part from the floor plates. In doing so, he inadvertently placed his left foot on the vertical flange of the angle iron frames holding the chequered plates. With almost his entire body weight resting on the heel of his left boot, which was supported on the edge of the angle iron, his footing slipped and his ankle rolled inward resulting in torn ligaments and a Lost Time Incident (LTI).

- 1 Inadequate work direction/preparation/JSA. The full implications of removing the safety chains and stanchions were not fully discussed / considered;
- 2 The JSA and risk assessment conducted did not adequately identify slips, trips and fall hazards.

Inboard Starboard Engine showing raised working platform and safety stanchions and chains

- 1 Engineering Supervisor and Master reviewed vessel-specific JSAs and identified areas which required further dissemination – including the removal of safety barriers;
- 2 A special safety meeting was held aboard the vessel to discuss the incident;
- 3 Operations Department distributed a Fleet Safety stand-down order, reviewing the circumstances and requesting feedback from the fleet;
- 4 Subsequent to this report, a more detailed account with root causes and lessons learned was distributed. This incident was also reviewed in detail during weekly fleet teleconferences.

- 1 A thorough risk assessment exercise meant to identify additional hazards related to safety barriers, particularly in the engine room, was commenced on all vessels;
- 2 Engineering Department is also reviewing platform design for modification, including steps or removable tool stations for periodic maintenance.

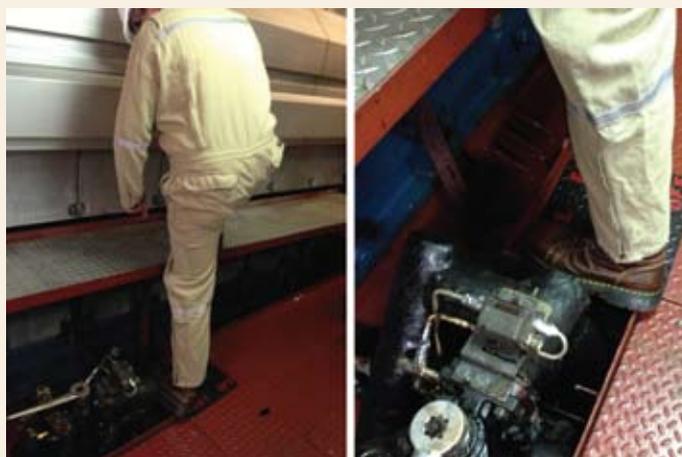
Re-enactment of mis-step and unstable footing

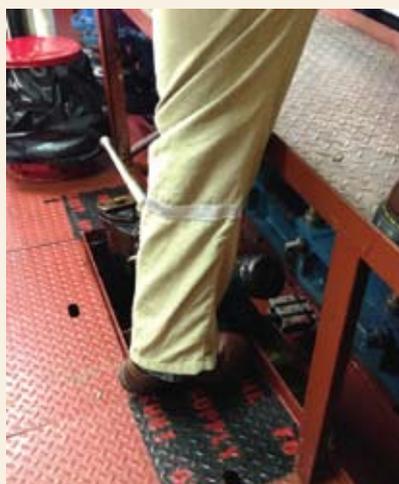
Another view of unstable and inadequate footing that resulted in the accident

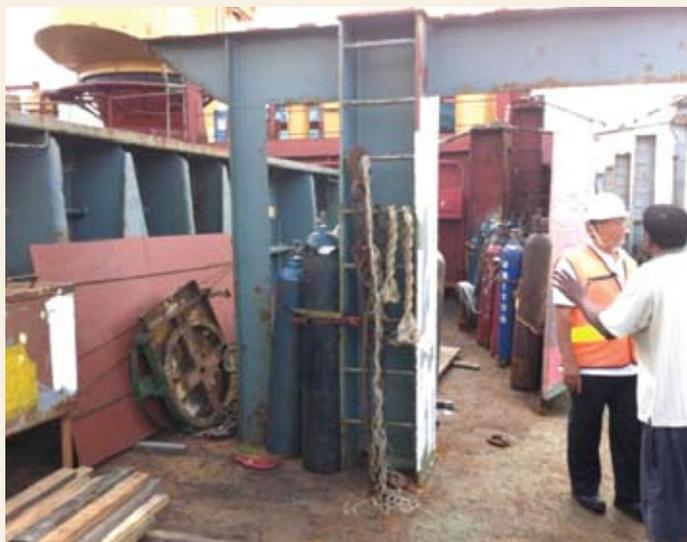
A vessel was discharging steel plates at our port, and passing the plates over many gas bottles which were on deck. There is always a slight chance that the cargo of steel plates can fall on the deck due to breakage of sling/crane wire. The consequences of these plates falling on top of these gas cylinders could be an explosion, followed by fire etc.

Discharging operations from that hold were stopped immediately and the bottles were removed. Discharging was only resumed when all the bottles were removed from cargo operation area.

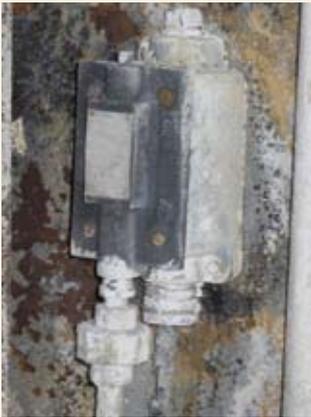
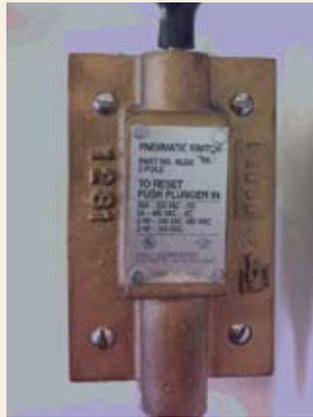
Recently, a vessel with an installed fixed CO₂ fire suppression system suffered extensive damage due to a fire that started in the engine room. During the firefighting efforts, the crew reported that the engine room ventilation could not be secured. A post-casualty damage survey of the vessel revealed that the pressure switch used to secure the ventilation

was located within the engine room [see photographs of the damaged pressure switch and new switch.]

The Coast Guard *strongly reminds* owners and operators of vessels with installed fixed fire suppression systems to ensure that these switches are properly located aboard their vessels. If the pressure switch or switches are located within the space being protected, they should be relocated by a properly trained fire suppression service technician. Doing so will assist in ensuring system functionality and accessibility in the event of an emergency. Failing to do so could have serious consequences to the vessel, its crew and the environment.
