Seaways

Mariners' Alerting and Reporting Scheme

MARS Report No. 242 December 2012

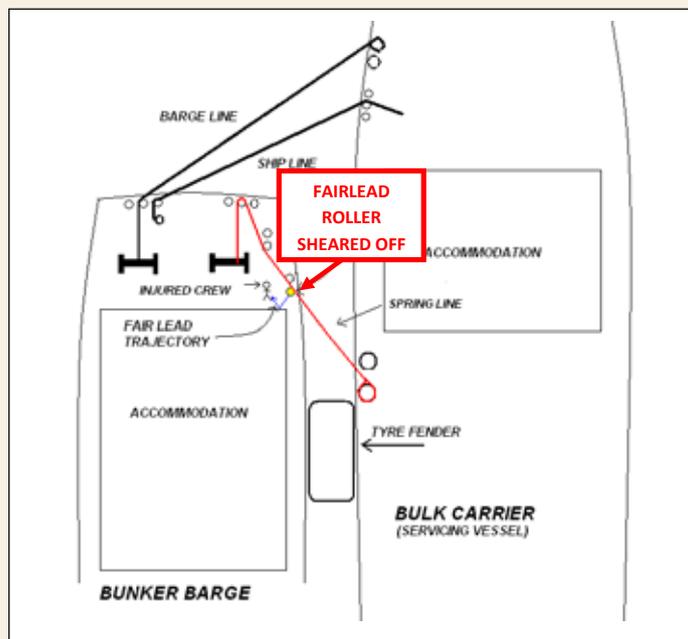
Due to the large difference in freeboard between the two vessels, the mooring lines from the barge's deck were all leading upwards subjecting the roller to a combination of large cyclical sideways thrust and lifting force. Ultimately, material weakness and fatigue caused by corrosion and wastage within the roller's body caused it to shear off from the base.

Diagram showing mooring arrangement at time of accident

View of failed fairlead roller showing the spindle and sheared base

- 1 A proper risk assessment must be conducted before commencing mooring operations, taking into account the effects of sea state, difference in freeboard, lead angles of lines and prevailing circumstances and conditions;
- 2 Mooring plan must be jointly discussed and approved by both supplying and receiving vessels;
- 3 If additional safety measures are not considered to mitigate risks to an acceptable level, the bunker transfer must be cancelled / postponed;
- 4 Mooring equipment must be properly inspected and maintained as per a documented planned maintenance system (PMS).

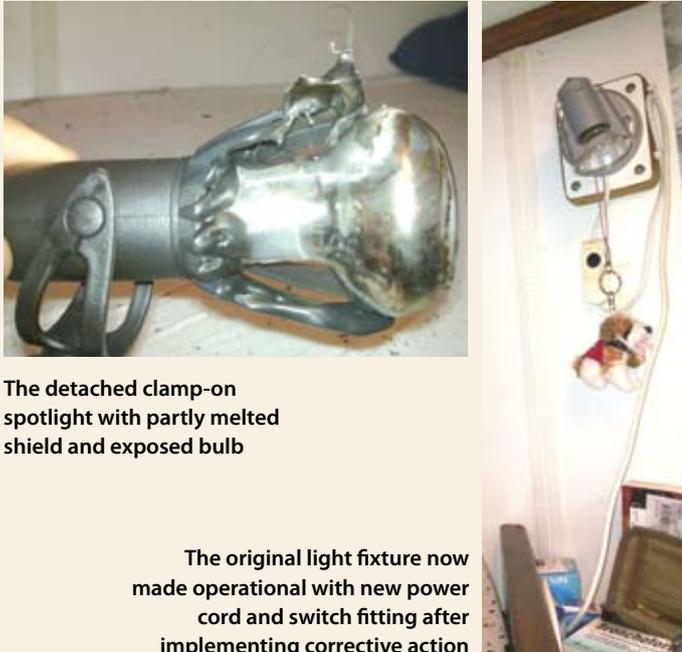
- 1 The cabin was originally provided with a proper bedside reading lamp, but as the switch could not be reached from the bunk, and because there was no spare to replace the fused bulb, a previous occupant had jury-rigged a non-approved light fitting by clamping it to the defective light fixture on the bulkhead;

- 2 The mate had neglected to turn off the portable light before going ashore. During his absence, the clamp had loosened and the light had fallen on to the bunk, heating the mattress spot in contact with the lamp to beyond its self-ignition temperature;

The detached clamp-on spotlight with partly melted shield and exposed bulb

The original light fixture now made operational with new power cord and switch fitting after implementing corrective action

The temporary light was removed and the original light fixture was restored and fitted with new electrical wiring incorporating a dimmer / switch combination secured within easy reach of the bunk.

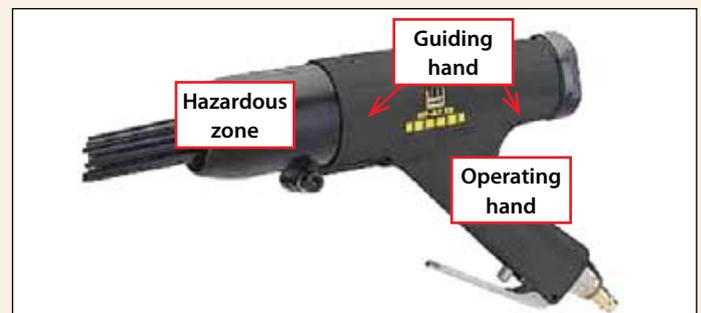
- 1 Proper PPE was in use;
- 2 A momentary lapse in concentration resulted in the finger coming into a hazardous zone;
- 3 Difficult access to a restricted space requiring the operator to manually guide the needle gun.

Typical compressed air-operated needle hammer gun with pistol grip showing safe and hazardous hand grip areas

- 1 It is important not to lose concentration when operating power tools and to keep body parts away from exposed moving components;
- 2 The operator must never grip the needle guide of a running pneumatic needle or chisel hammer gun;
- 3 Incidents must be reported as soon as they occur.

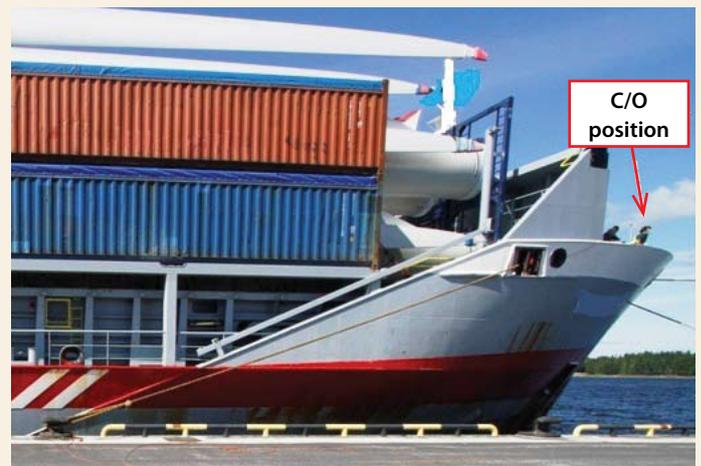
View of ship's fore end showing location of C/O during mooring operation

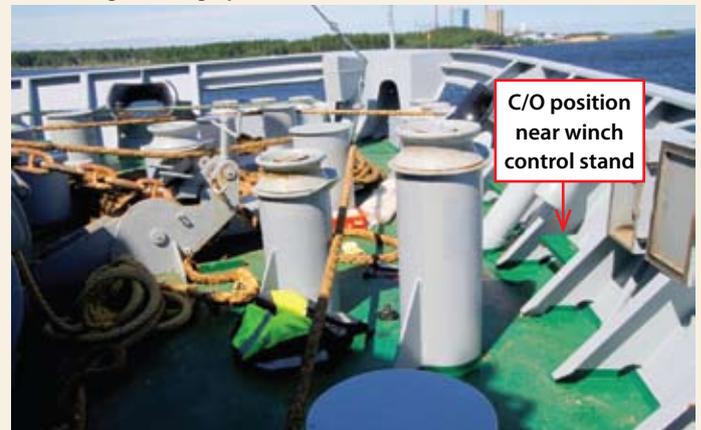
C/O was standing in snap back zone when rope parted

- 3 The C/O failed to move away from snap back zone even after being warned by Master;
- 4 Poor design - Confined/restricted area on the forecastle deck and improper location of winch remote control unit;
- 5 The company had no specific guidelines for mooring and the company management had not identified mooring to be a hazardous operation.

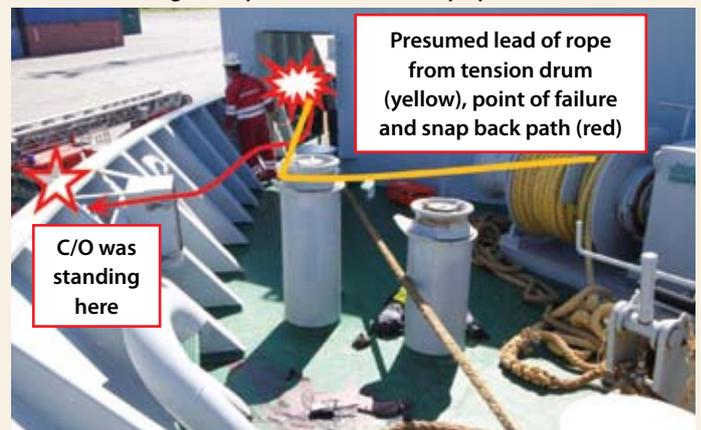
Possible path of fatal snap back

Editor's Note: Although the report does not specify the actual point of failure of the hawser, it is likely that the newly inducted line parted at a stress point or nip that would have developed at the multi-angle fairlead when the vessel was moved with a prolonged ahead engine kick. This incident clearly illustrates how the sudden linear contraction of a synthetic fibre rope parting under excessive tension can cause injury/damage at a considerable distance from the point of failure.

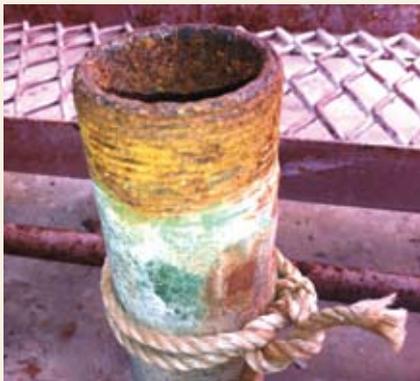
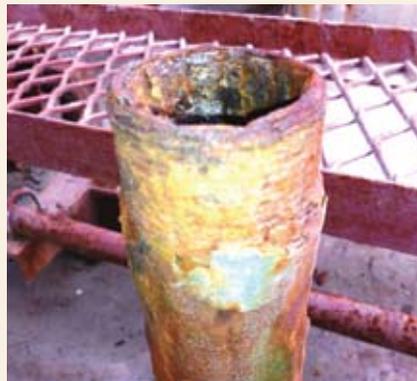
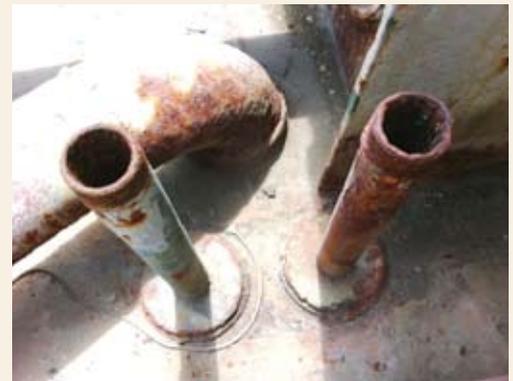
→ The three photographs below show evidence of the lack of regular tank/ bilge monitoring on board. Sounding pipes with missing/ ineffective caps can potentially lead to progressive flooding and cargo damage. Such vessels are clearly unseaworthy and must be detained by authorities for violation of the loadline and SOLAS conventions until effective closing arrangements have been fitted. It is good practice to include sounding pipes in the ship's planned maintenance system, ensuring that every sounding pipe is regularly inspected along the entire length to the extent possible and the section exposed to the weather is kept free of corrosion and wastage, and threads of the pipes and caps are regularly dressed and greased.
